CONNECTICUT RIVER BASIN  
NORTHFIELD, MASSACHUSETTS

NORTHFIELD SCHOOL UPPER RESERVOIR DAM  
MA 00051

PHASE I INSPECTION REPORT  
NATIONAL DAM INSPECTION PROGRAM

APRIL 1981

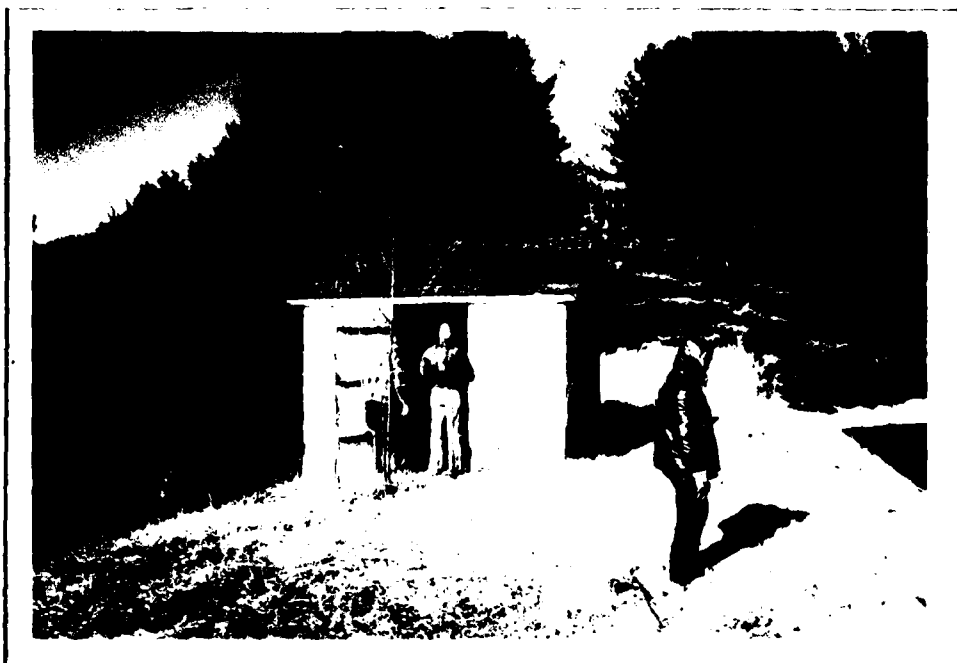
was observed to have superficial spalling at its exposed exterior corners. To discourage vandalism, windows have not been installed in the gatehouse.

The dam was observed to be in fair overall condition. No obvious signs of settlement or structural movement of the dam were observed. Minor spalling was observed at the corners of the gatehouse, but no structural deficiencies were observed. The interior walls of the gatewell were not examined; however, Mr. Wayne Black, Water Superintendent, believes the walls are in good condition.

3. GATEHOUSE ON CREST OF DAM. (2487)

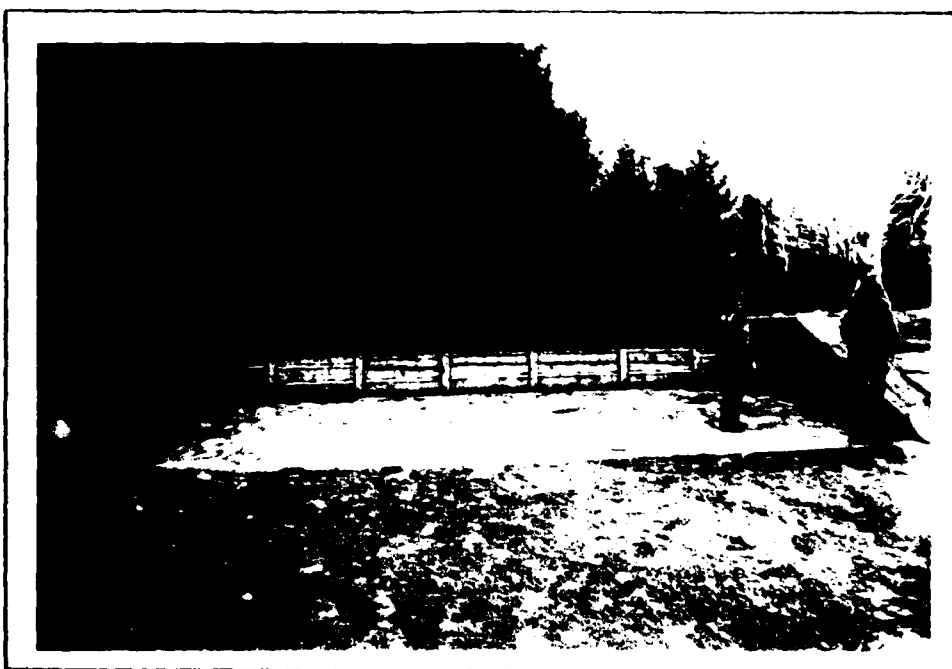
4. SPILLWAY INLET CHANNEL AND SPILLWAY. (2488)

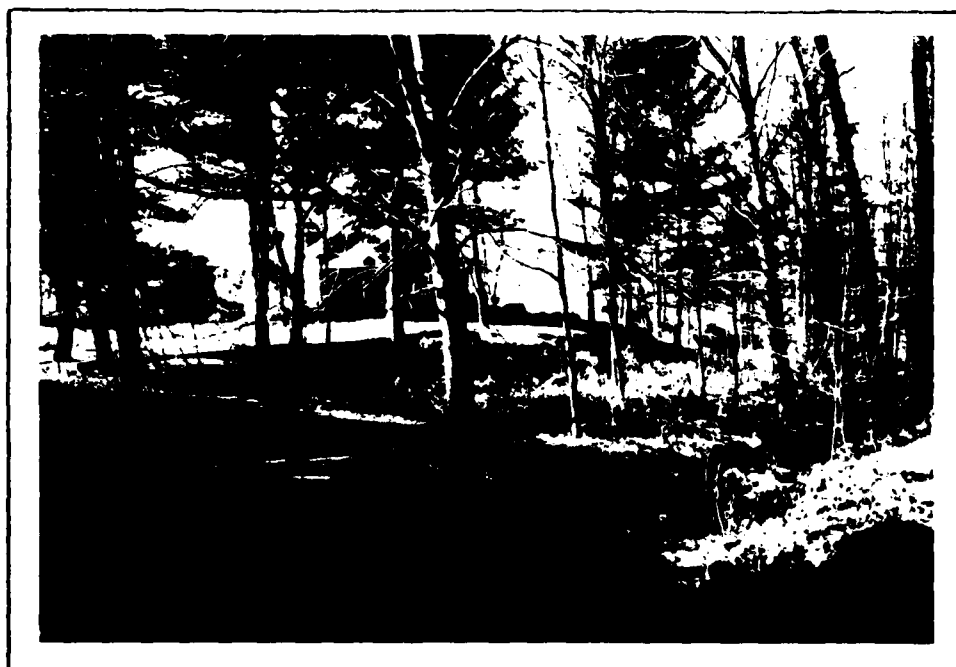
10. POTENTIAL PASSAGE AREA APPROXIMATELY 3000 FEET (12/4/80)  
DOWNSTREAM FROM THE DAM.
